PROJECT LOCATION
BOARD OF EQUALIZATION BUILDING
450 N STREET
SACRAMENTO, CA. 95814

PROJECT
STATE OF CALIFORNIA, DGS
BOE ASSESSMENT
(LCD NO. 2372-572)

DESCRIPTION
WATER DAMAGE
SURVEY

LOCATION
GROUND
FLOOR

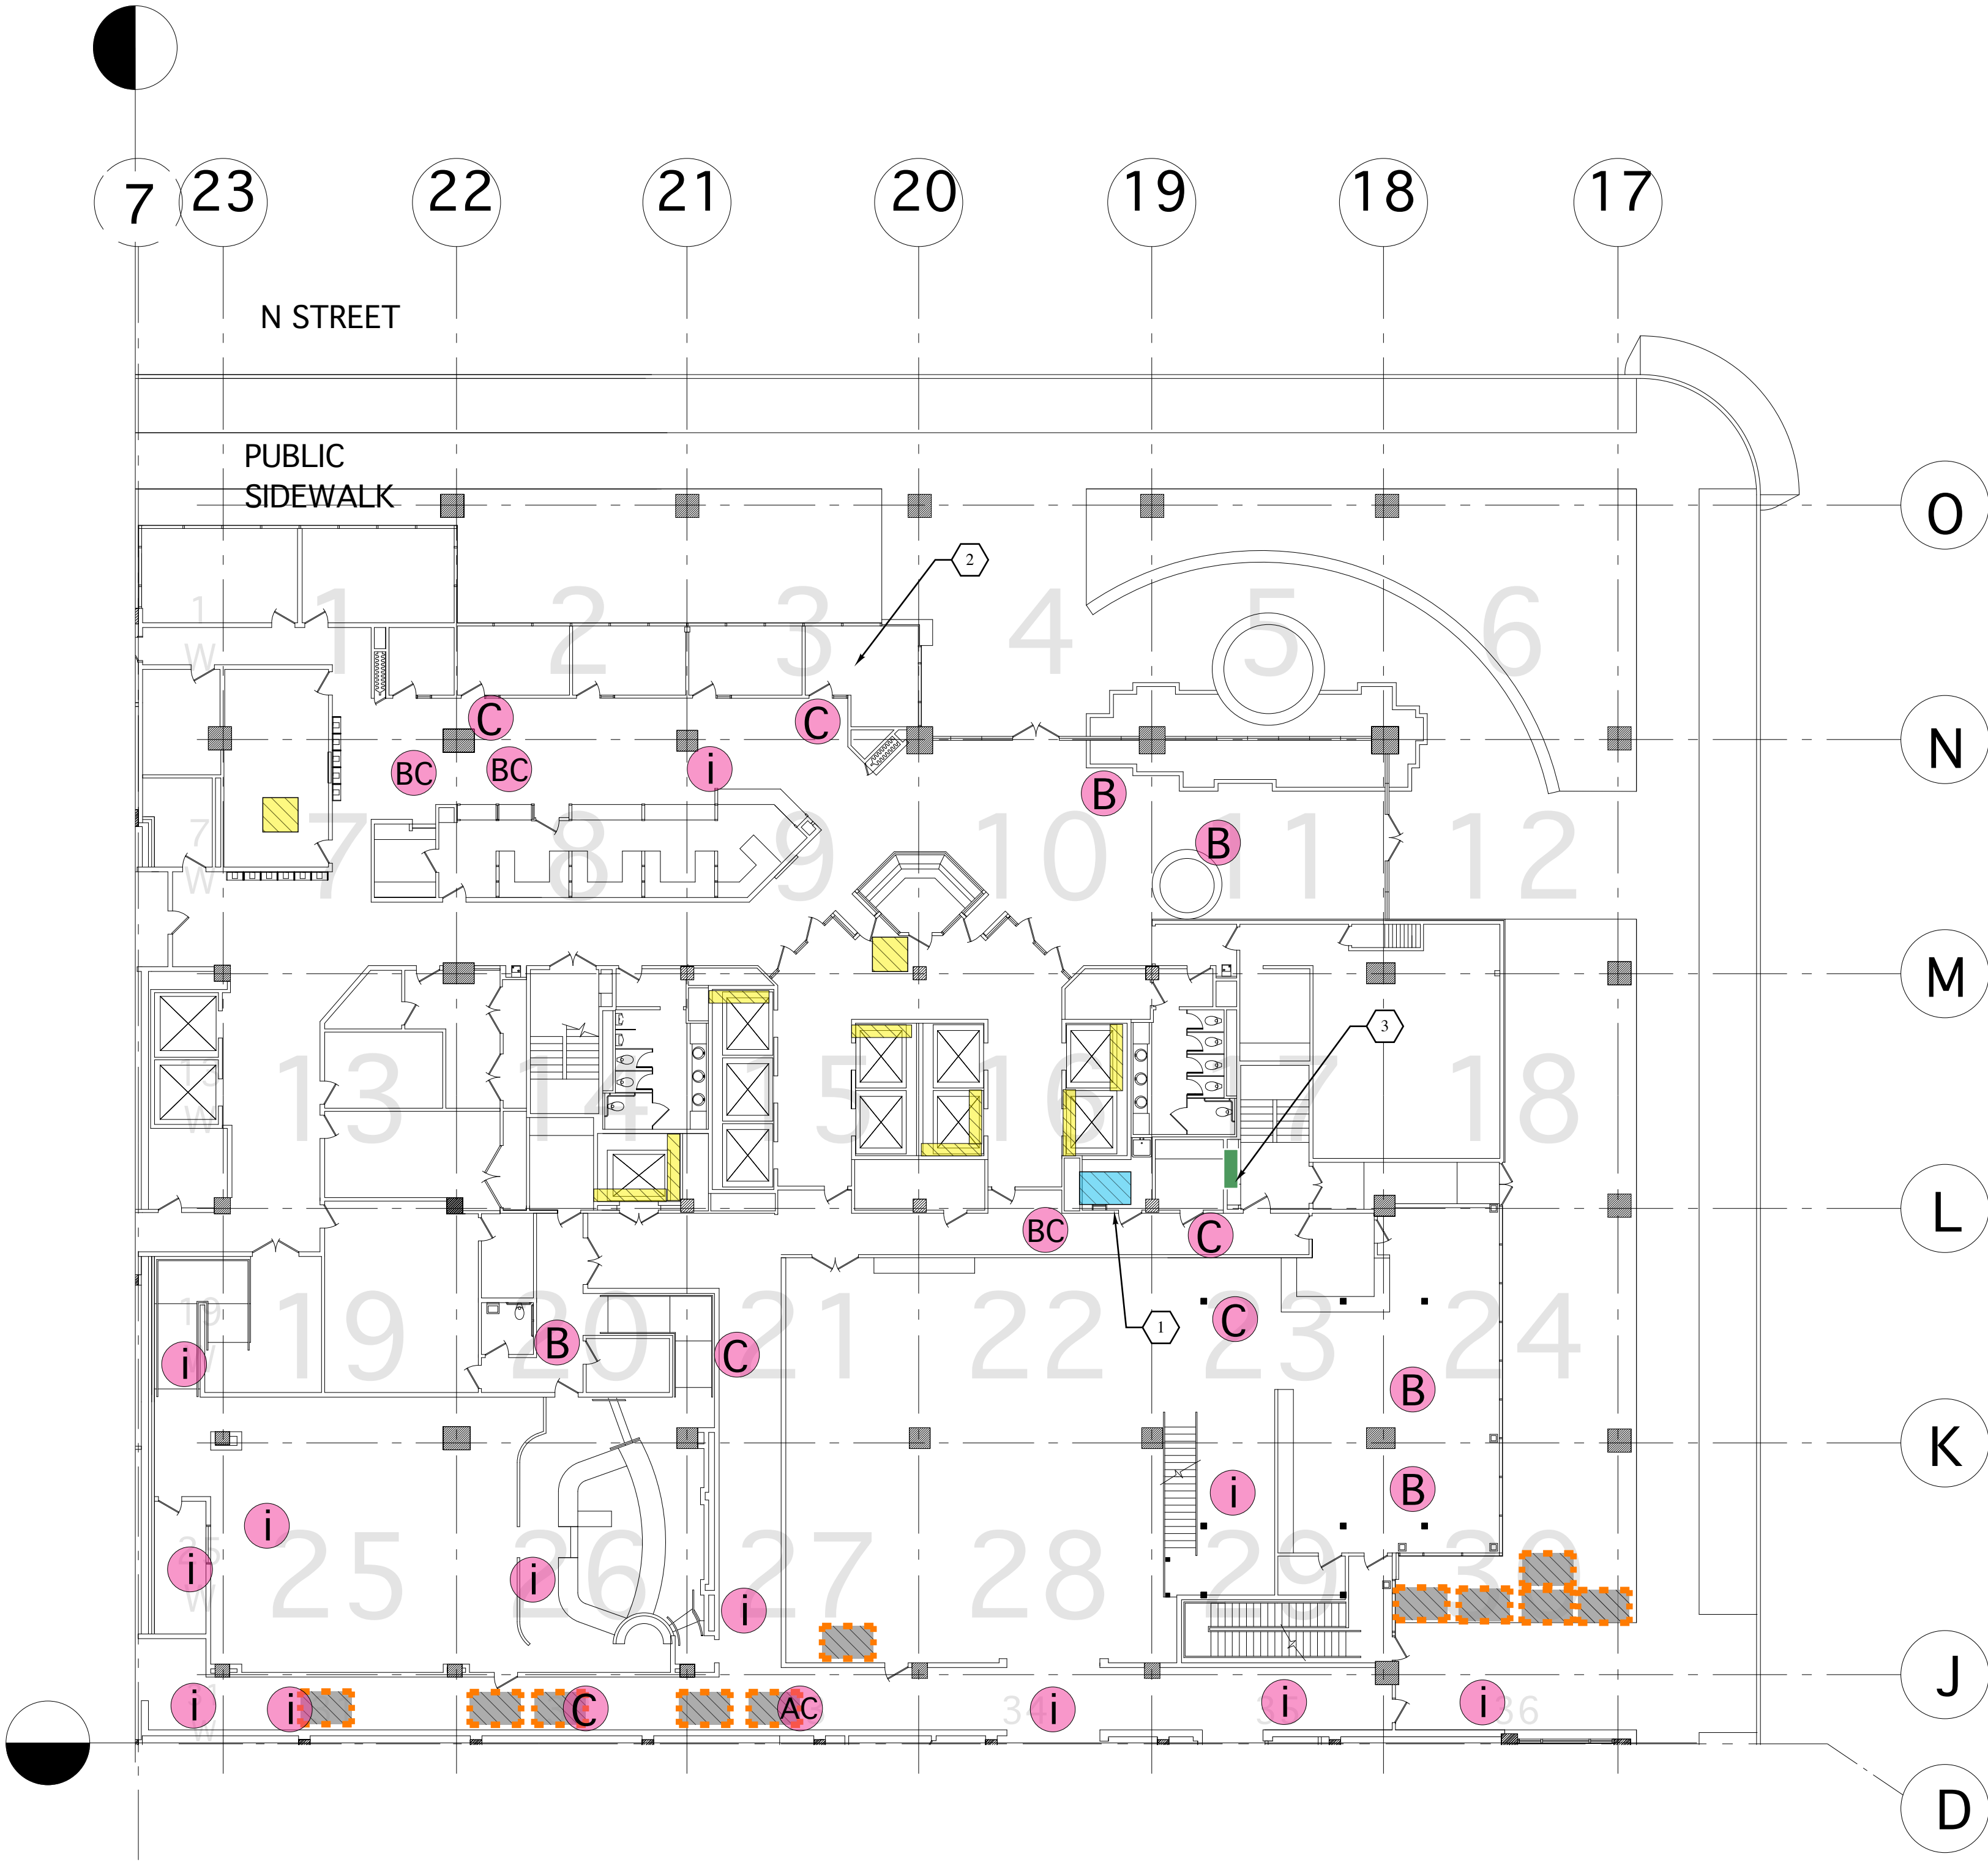
FLOOR PLAN N/E QUADRANT
SCALE: 1/8" = 1'-0"

L/19 WEeping PIPES WITH WS ON WALLS AND CLGS.
- 2

N.5/20 CITY STORM DRAIN CAUSE OF WATER DAMAGE (HISTORIC)
- 3

L/18.6 FIRE SPRINKLER RISER VMG
